THE SAFETY CURTAIN, ROYAL THEATRE, NORTHAMPTON

In 2023 **Chroma Conservation** undertook the Heritage Lottery Funded conservation treatment of the Safety Curtain in the Royal Theatre, Northampton. The wonderfully eccentric painted depiction on the safety curtain was created in 1978 by Henry Bird and is known as *Sipario Dipinto* or *Separator Painted*. This important feature was inspired by sources such as *Commedia dell'Arte* and *Hamlet's mirror*. It depicts a series of vignette portraits including the artists' wife and muse, the actress Freda Jackson and most notably Errol Flynn who was a member of the Northampton Repertory Players in the early 1930s.

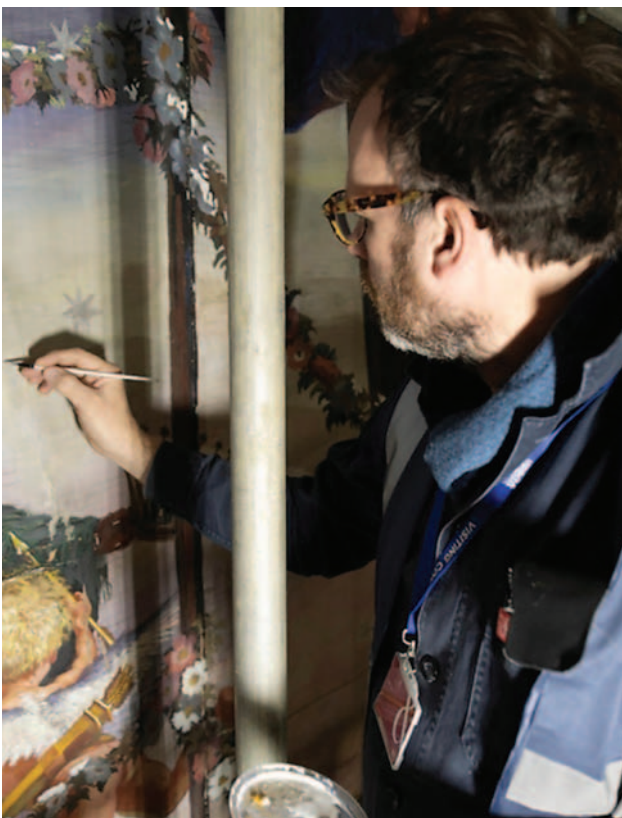
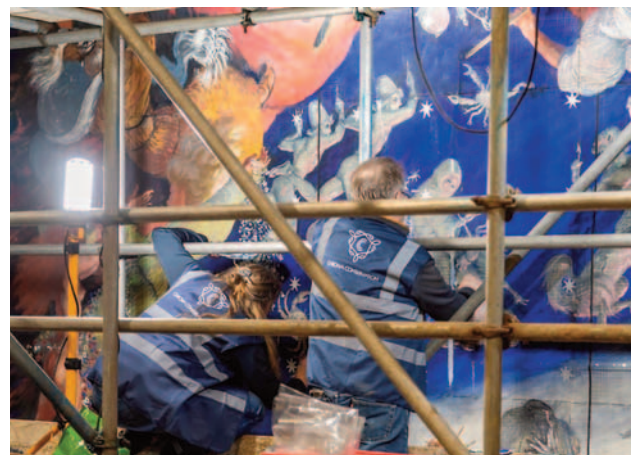
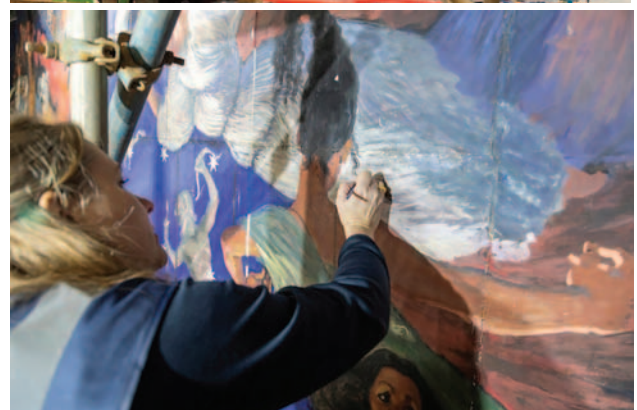
Above and opposite, work on the curtain

The safety curtain was lightly brushed and carefully vacuumed to remove surface dust and then dry cleaned using Akapad (Wishab) sponges which are made of vulcanized latex and by gently rubbing the surface remove the soiling and revive the soft chalky distemper layer of paint. All areas of flaking paint were then consolidated and paint losses were retouched.

Previous crude repairs were removed and replaced whilst areas of missing decoration were reconstructed using casein paints to reintegrate the illustration. The paint system used ensures that the treatment is reversible and stable and the corrections to the mechanism mean that the surface of the painting no longer rubs on the wall above.

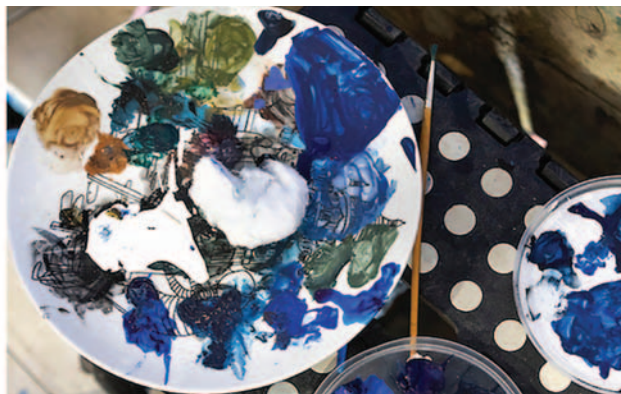
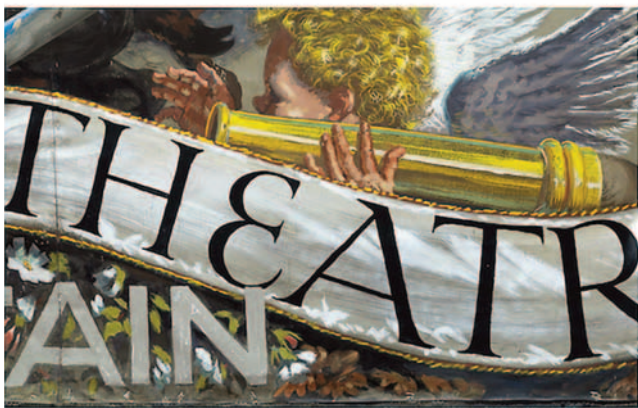
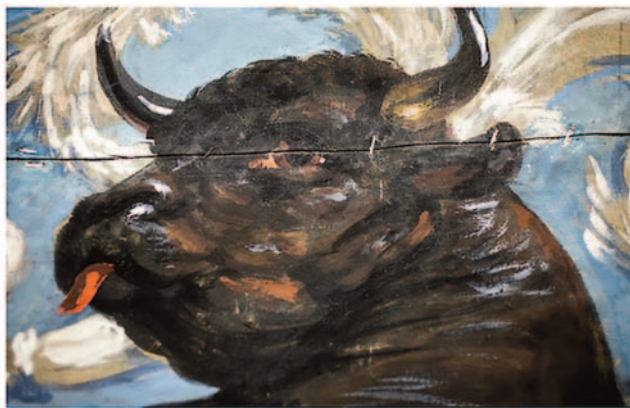
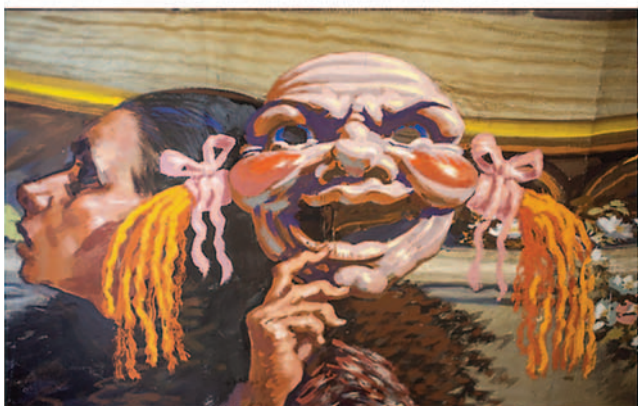
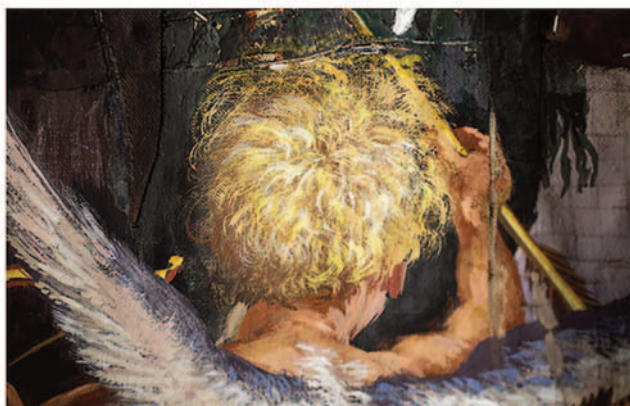
*Below, details of the curtain
Opposite, paint palette*

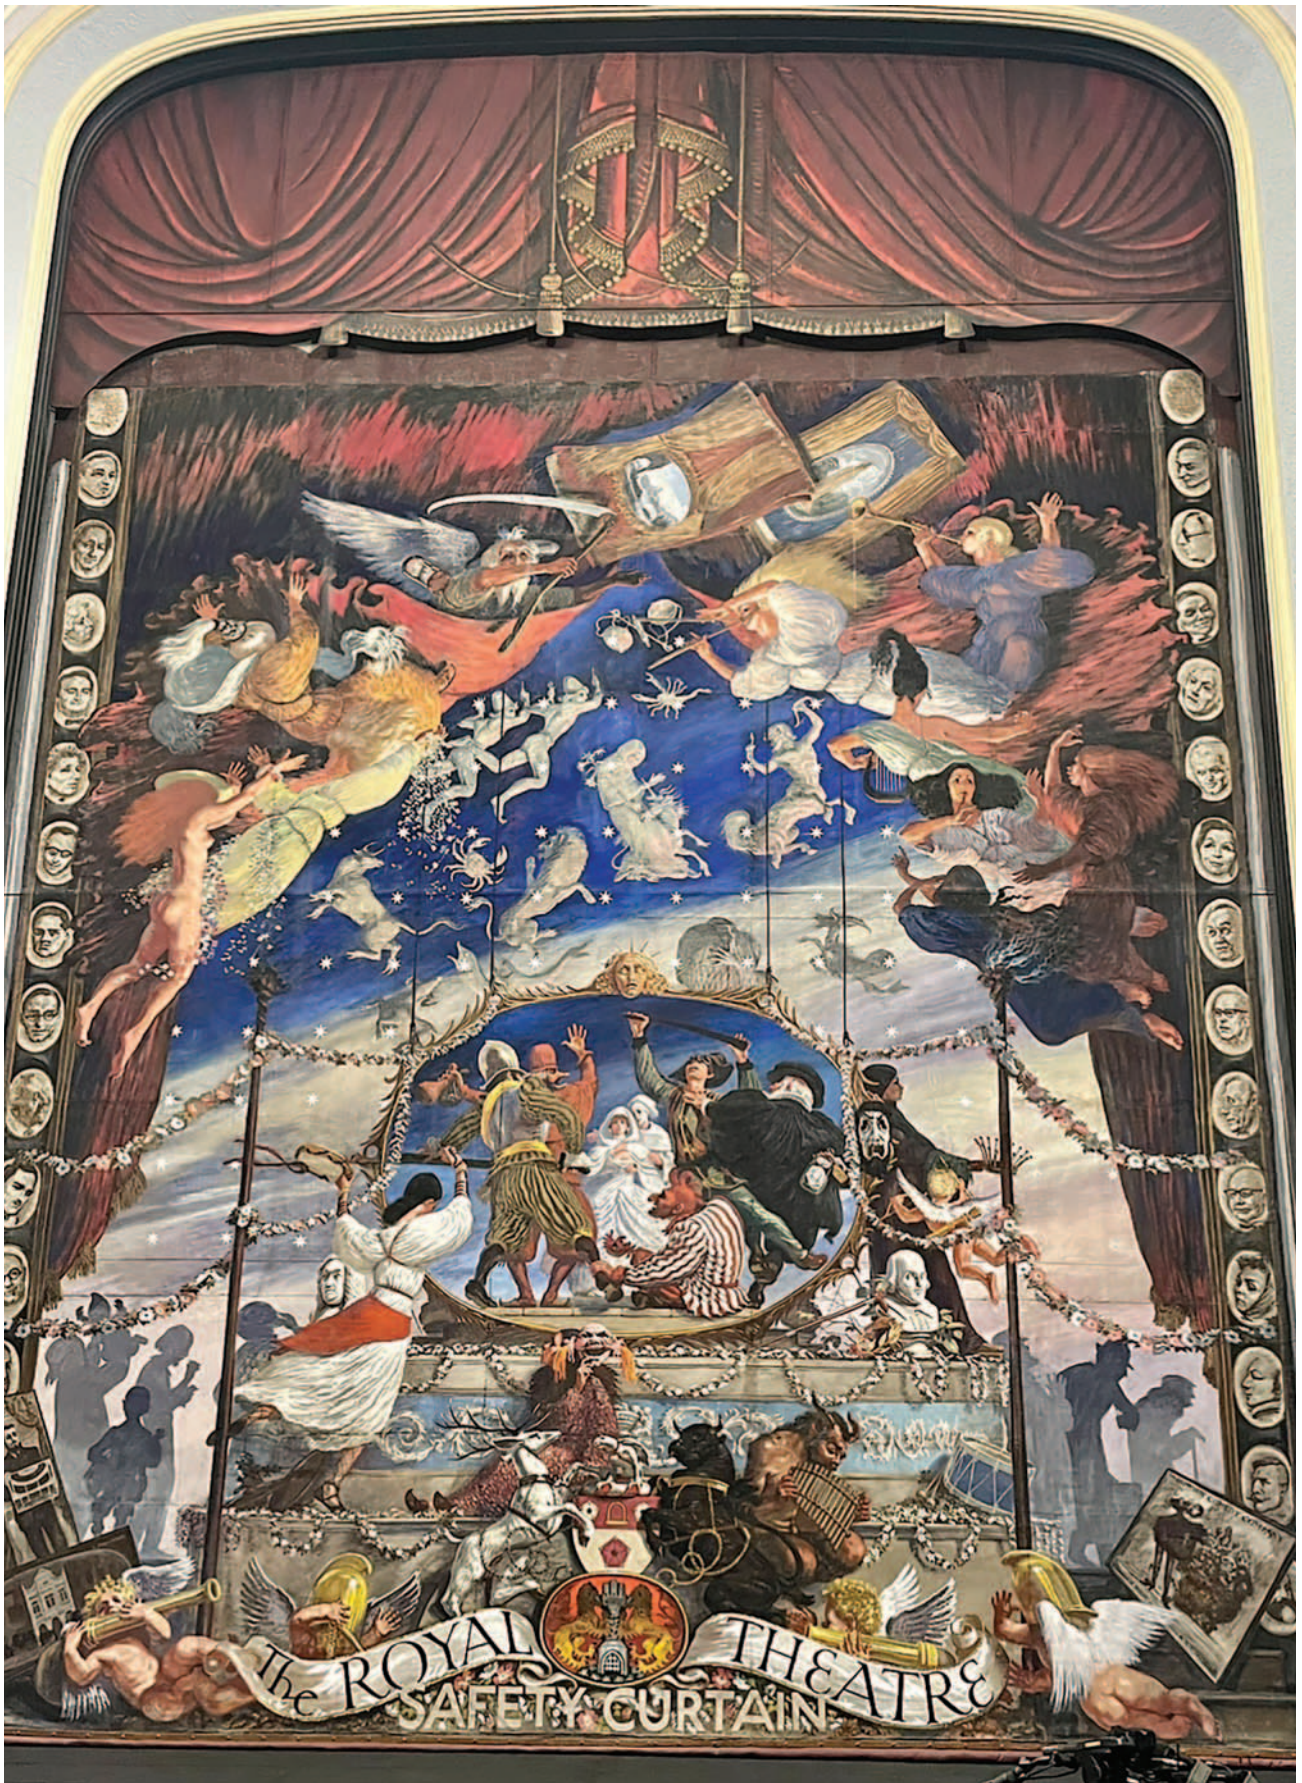
Above, safety curtain
