# THE TEMPLE ROOM, STOWE HOUSE, BUCKINGHAMSHIRE

*It was an honour for us at Chroma Conservation to have been commissioned to conserve and restore the plaster ceiling, cornice and architectural joinery (as part of the wider restoration) of the Temple Room at Stowe House, so re-named by the school after one of the boarding houses. It was originally known as the State Drawing Room and was created when the house was remodelled in 1774. It now acts as an overflow of the dining room for the school.*

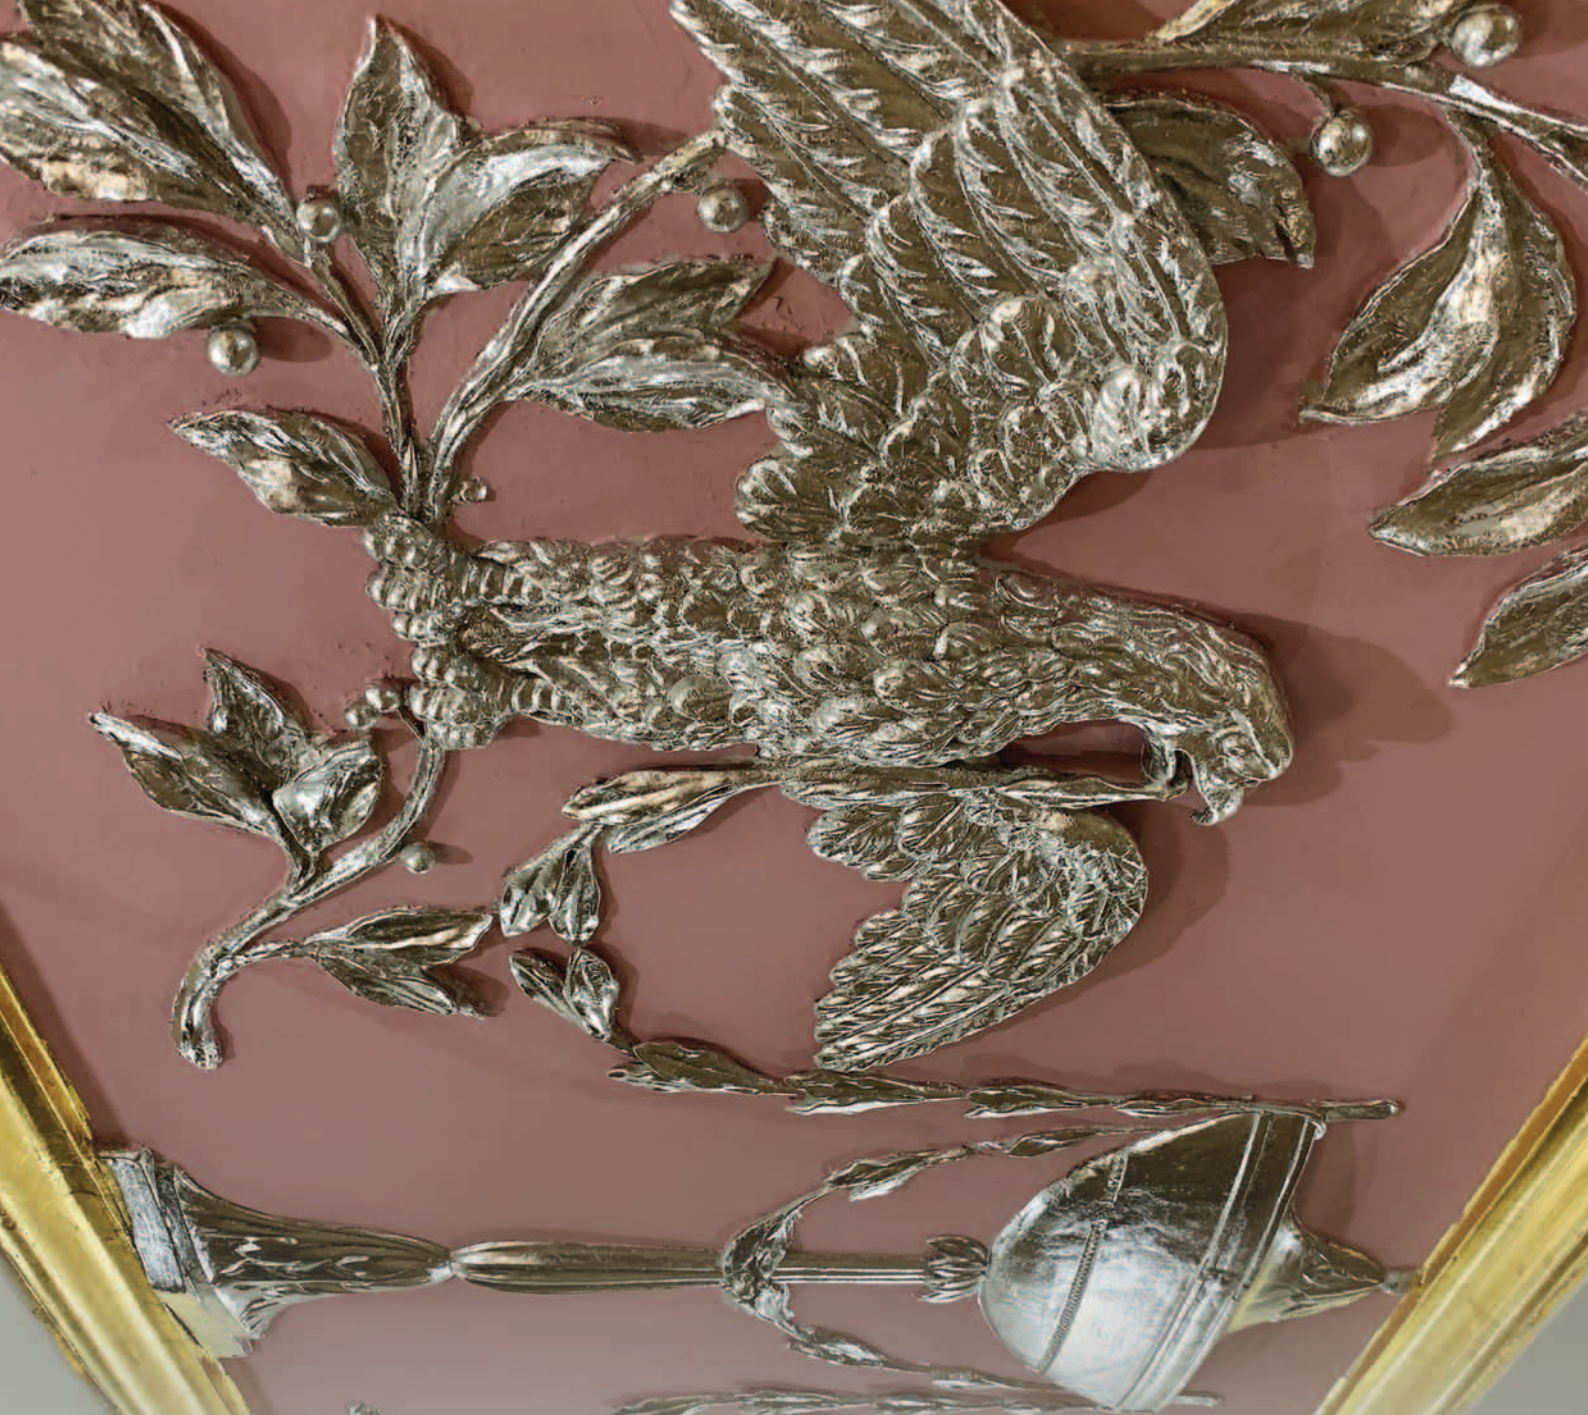
*Above, platinum eagles*

Following all the preparation the re-decoration started with primer stain block paint and undercoat applied on all areas. A yellow eggshell background was applied as a ground for the gilding. We used 23.5 carat gold for gilded elements and platinum for the eagles. All three varying pink shades were used and were prepared by Patrick Baty at Paper and Paints.

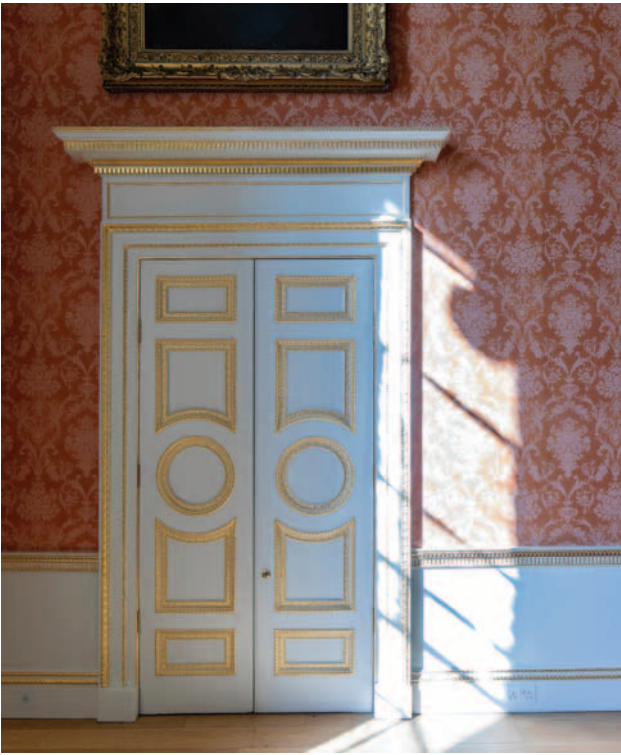
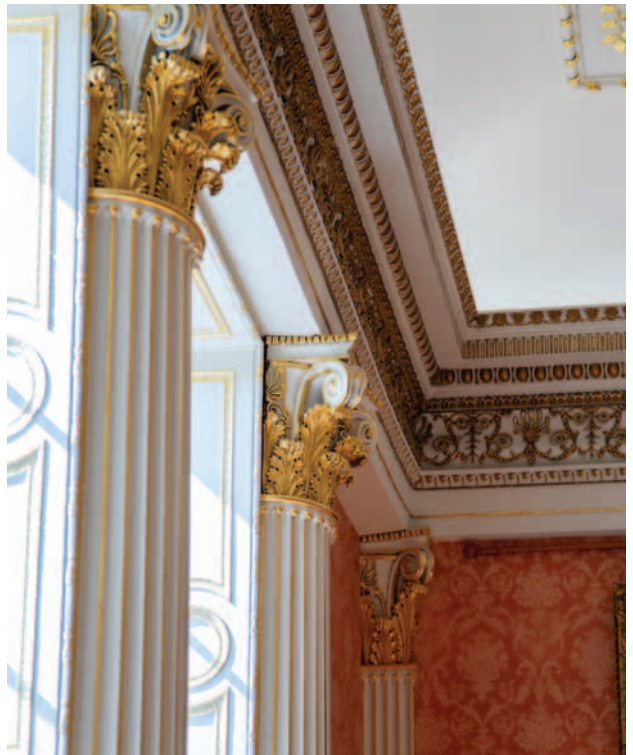
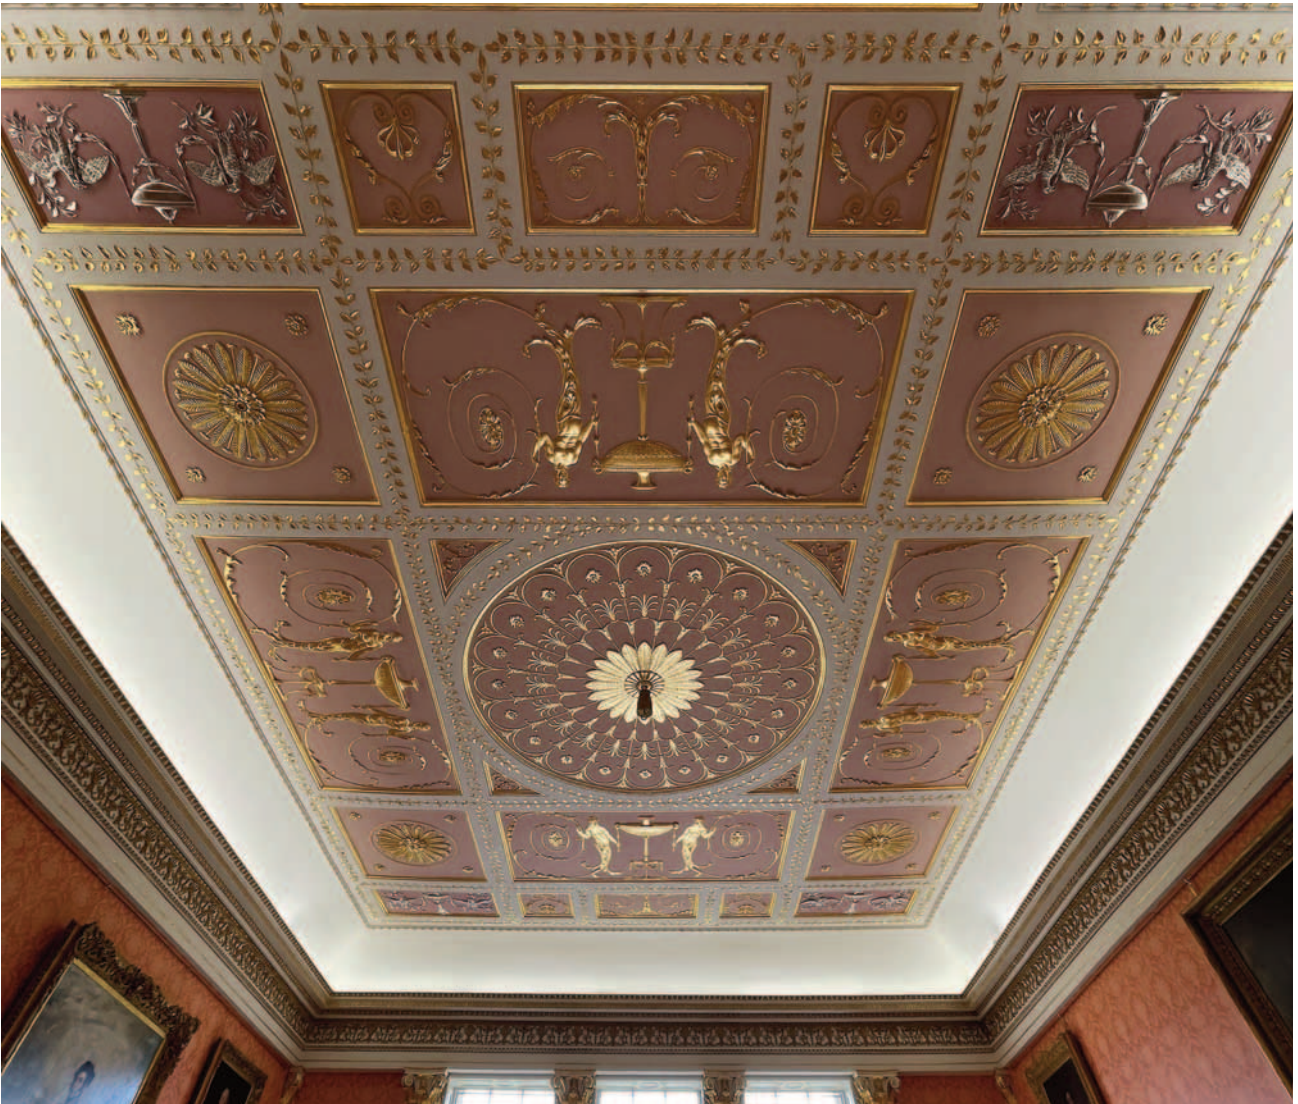
*Above, plaster after treatment*

It was discovered through analysis that the decorative mouldings belonging to the off white joinery had been gilded 9 times prior to our restoration treatment. Records show that these mouldings had first been gilded from 1780. At some stage the fluting of the columns had been overpainted in bronze paint which had badly oxidised, now reinstated with 23.5 carat gold leaf.
