THE CREATION OF PANDORA BY SIR JAMES THORNHILL, WOLLATON HALL

Chroma Conservation were approached to assess the condition of the ceiling in the South State Staircase at Wollaton Hall in Nottingham in 2022 and in 2024 (working with the conservation architects Purcell) their conservation treatment began. Upon completion, as a result of their efforts, in June 2025 this incredible building qualified to be removed from Historic England's Heritage at Risk Register.

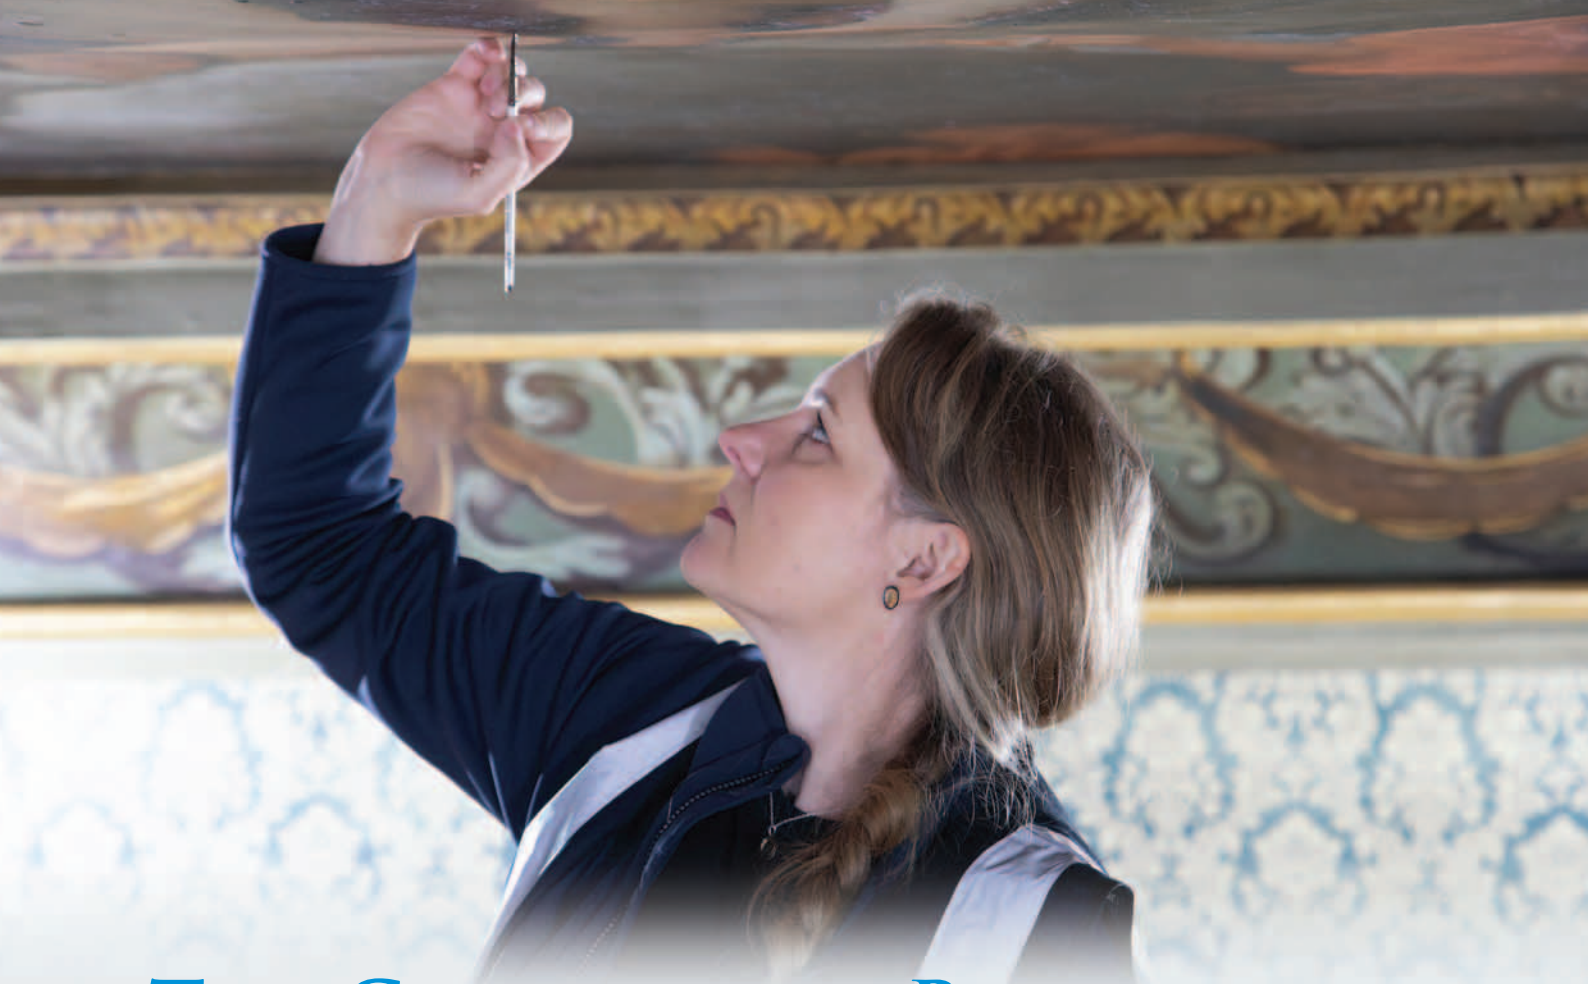
The ceiling painting depicts The Creation of Pandora who, according to Greek mythology, was the first mortal woman, formed out of clay by the gods.

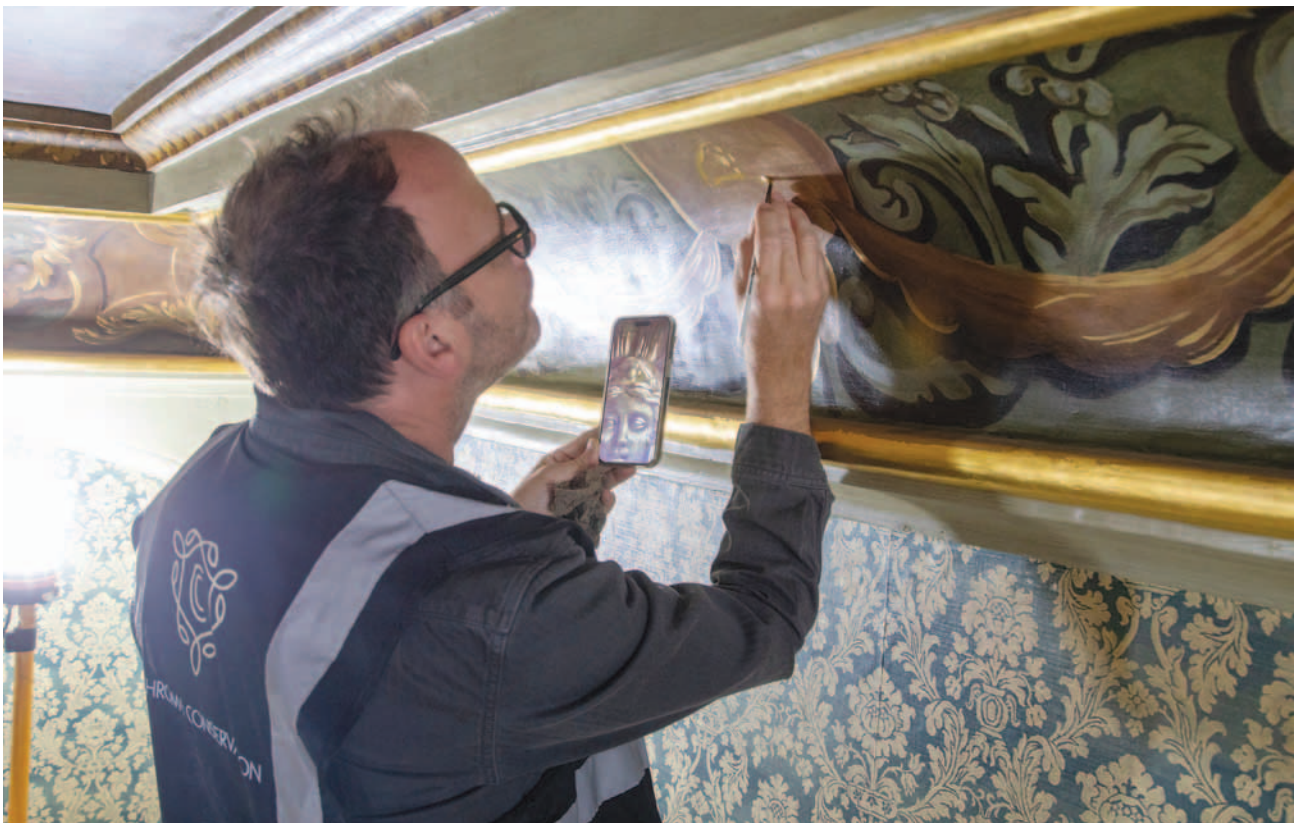
The East elevation cornice had suffered from roof and internal drain leaks and had received a skim of inappropriate modern gypsum plaster over the damaged surface. However, the problem was never resolved, the roof continued to leak with the modern plaster repair becoming unstable.

The entire length of cornice was displaying salt efflorescence which meant it had to be stripped and allowed to dry after having been trapped by the non breathing gypsum repairs.

This entire length of cornice was repaired to allow the recreation of the decorative scheme, depicting faces or masks of men and women surrounded by a repeating Acanthus leaf motif and the intriguing double Green Man

image in each corner, to simulate the cleaned and conserved original North, South and West cornice elevations.

The top and bottom roundel mouldings of the entire cornice were also re gilded with 23.5 carat gold leaf. Paint research confirmed that these were originally gilded and that the top flat mouldings and bottom spoon mouldings were painted with an off white/green shade.

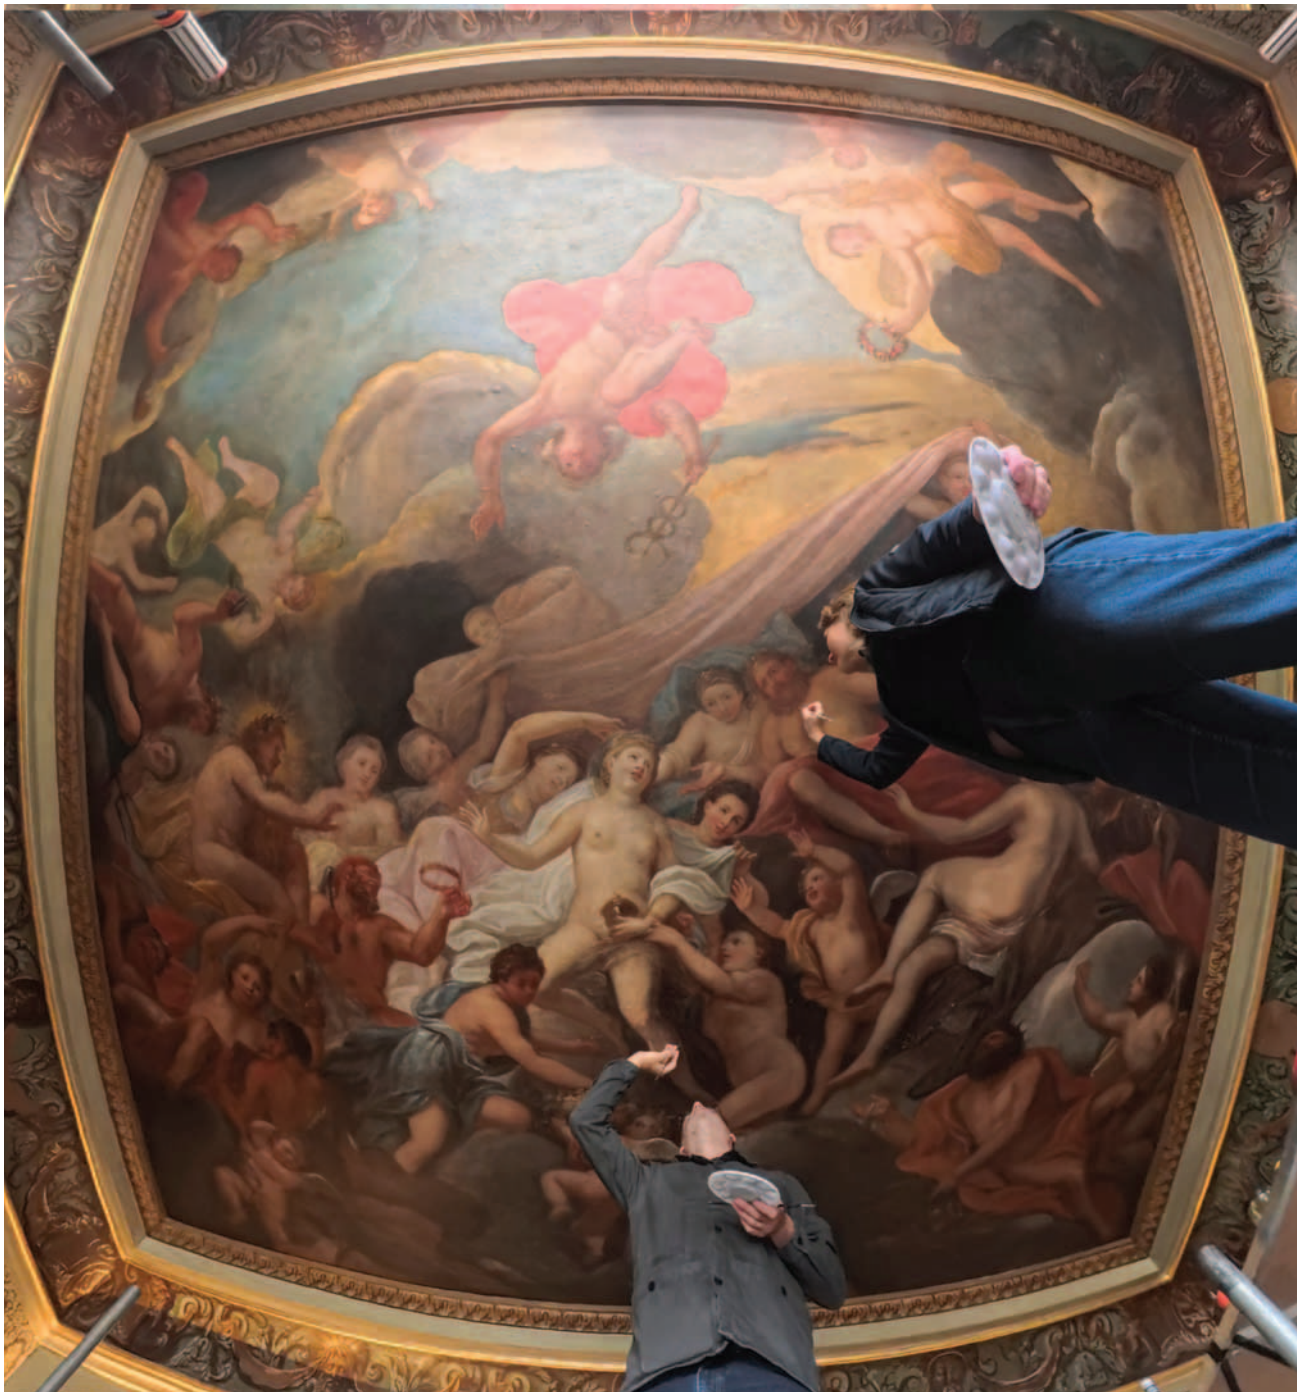
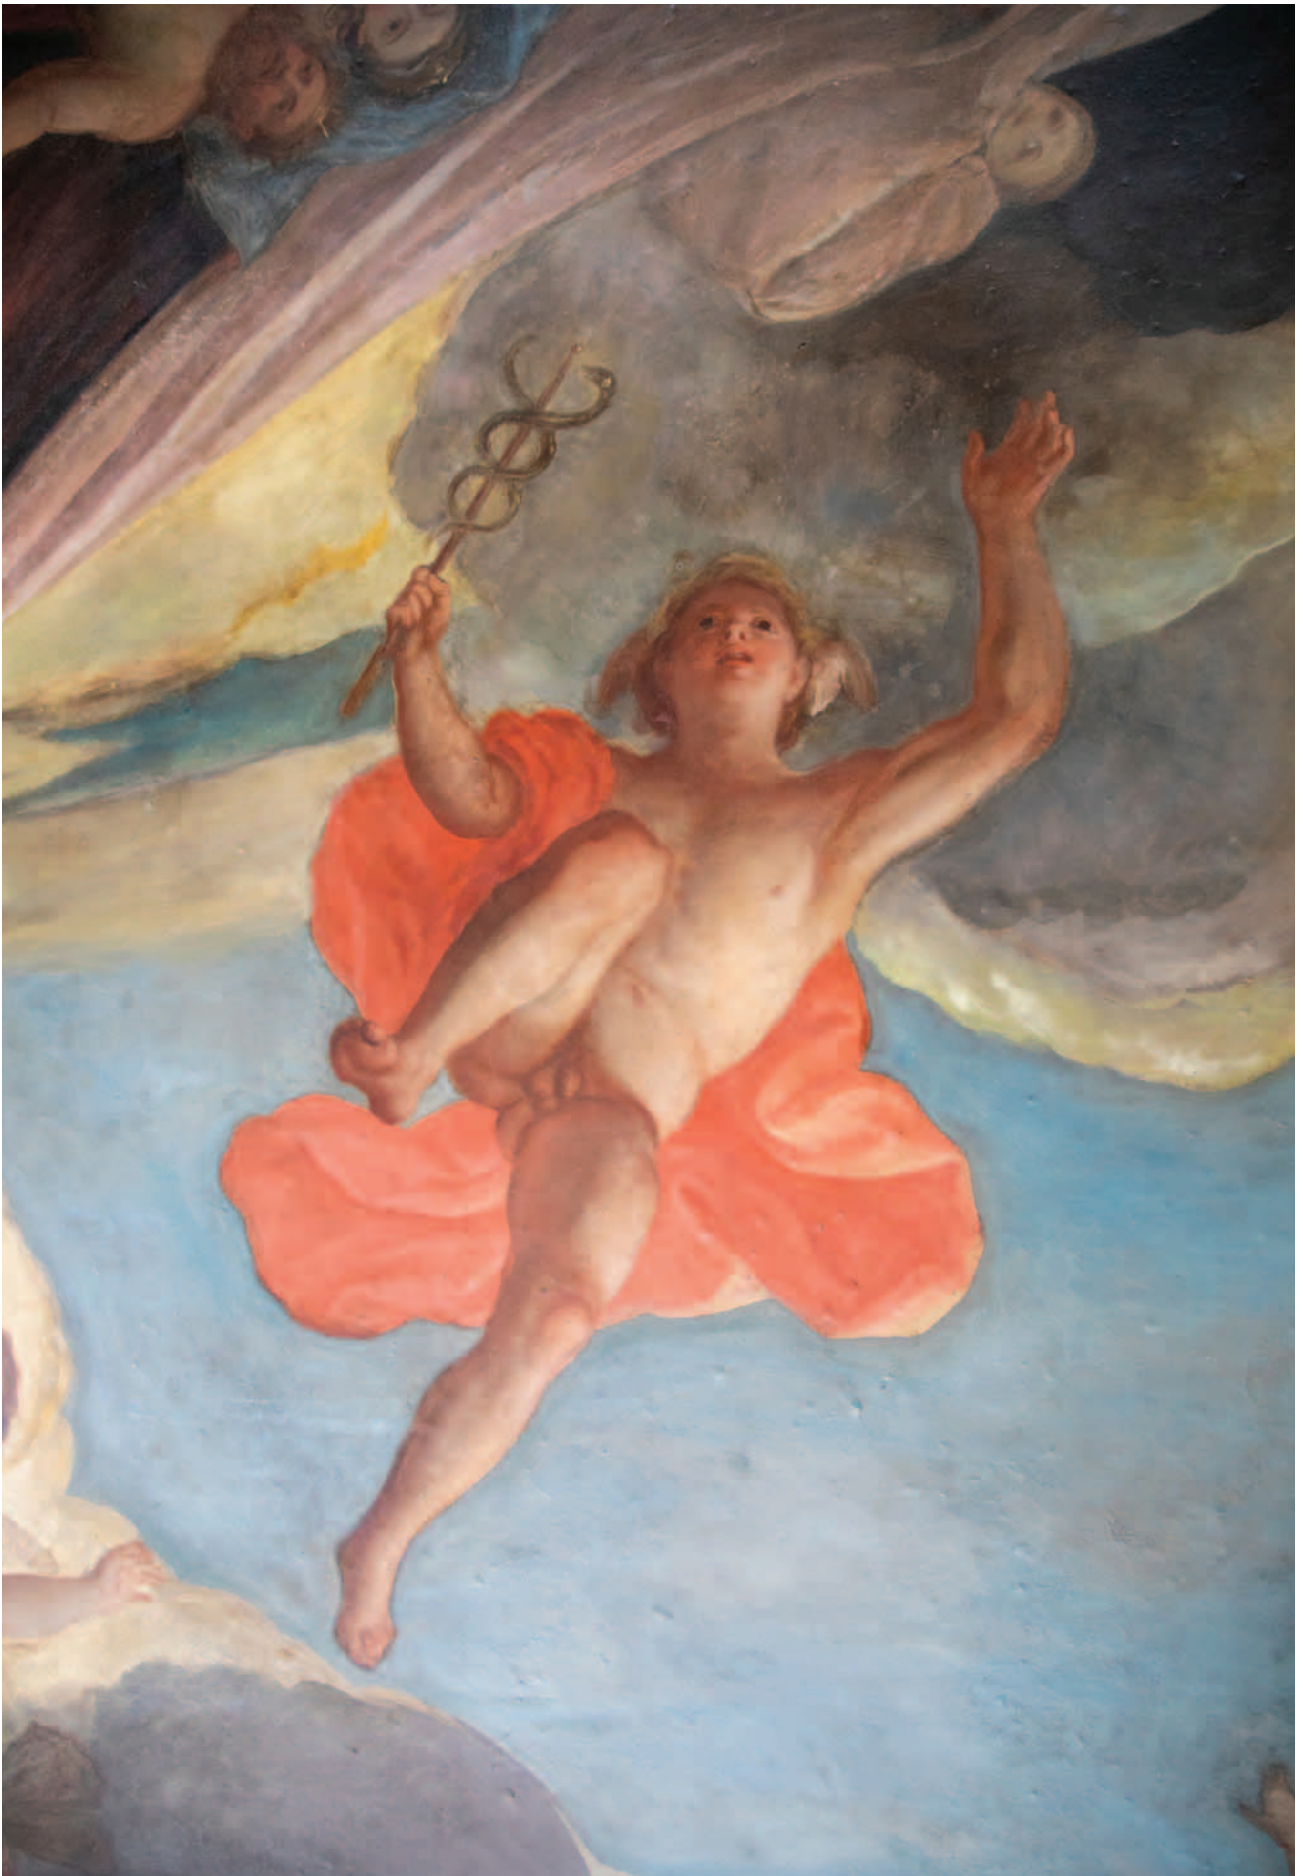
The ceiling and cornice had many patches of unsympathetic retouching and indiscriminate overpainting in an attempt to disguise the extensive damage caused by the cracks and leaks. These and the many thick layers of heavily discoloured oil varnish were removed after

Following this the conservators applied filler to the remaining cracks and repairs in the plaster surface before beginning the task of retouching the many paint losses and in painting of areas which required more extensive sympathetic reintegration along the crack line caused by the movement of the principal beam and water ingress

which gathered in this dropped section running approximately one metre parallel to the East wall. The conserved ceiling was varnished with a modern non yellowing solvent based system.

carrying out trials using chemical swabs to help establish the most efficient and least invasive approach to uncover the original Thornhill masterpiece.

After weeks of conservation cleaning and consolidating and fixing of detached paint layers an isolation varnish coat was applied to serve as a reversible barrier to protect the original ceiling and cornice painted decoration.

The end result is quite remarkable and has lifted the oppressive veil of dark yellow brown aged wax varnish, revealing a very pleasing clarity of colour and form, as conceived by the master painter himself. The Creation of Pandora can now be fully appreciated for generations to come.
